National Hump Crossing Database: The Latest

Francesco Bedini Jacobini, General Engineer
Office of Research Data and Innovation

U.S. Department of Transportation
Federal Railroad Administration

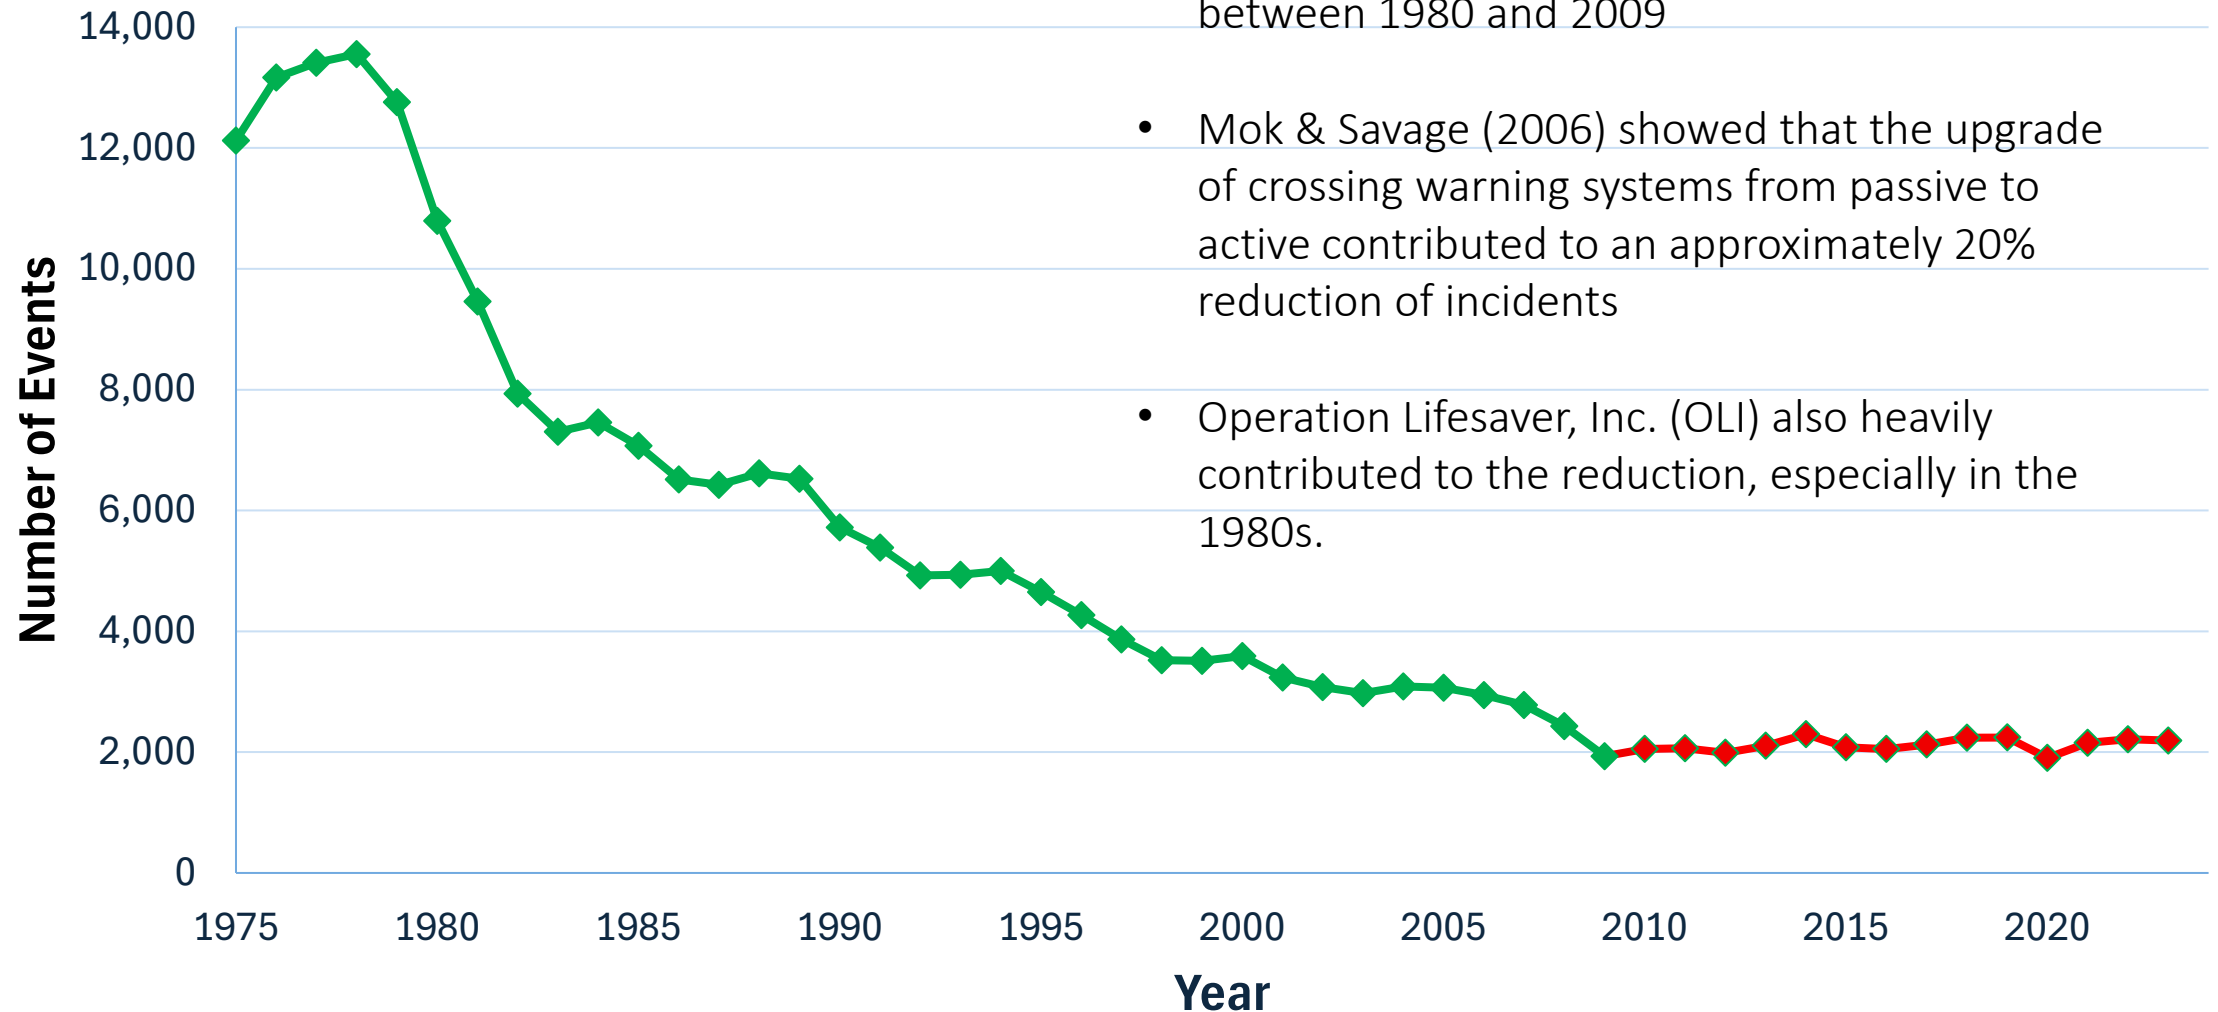
After a 30-Year Decline Incidents Are Again Rising

- There was a six-fold reduction in incidents between 1980 and 2009
- Mok & Savage (2006) showed that the upgrade of crossing warning systems from passive to active contributed to an approximately 20% reduction of incidents
- Operation Lifesaver, Inc. (OLI) also heavily contributed to the reduction, especially in the 1980s.

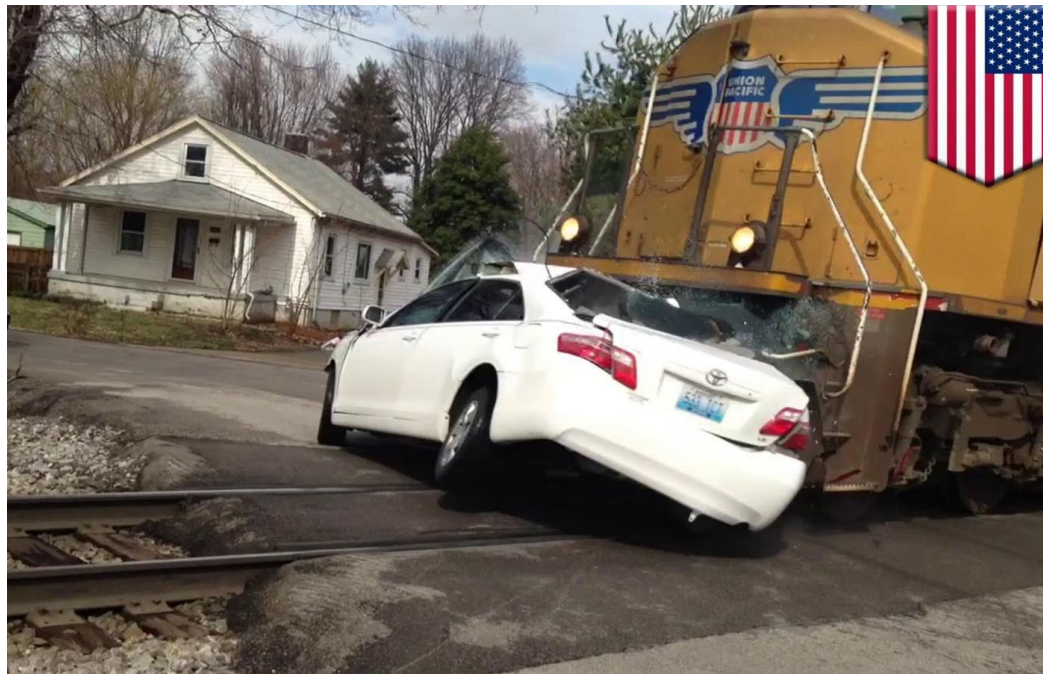
Train strikes vehicle (TSV)

- ▶ The percentage of TSV incidents has increased over the past two decades
- ▶ TSV incidents can occur when a vehicle's underbody comes into contact with the crossing surface causing it to become lodged and unable to continue to clear the crossing (vehicle hang-up)

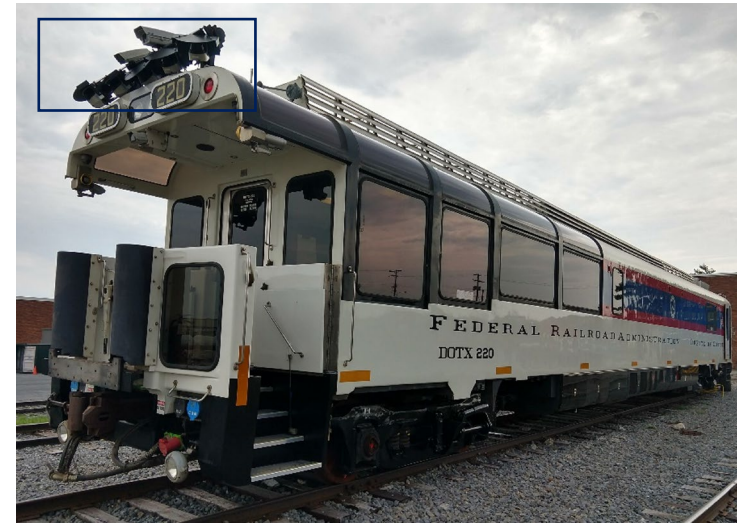
ATIP car with LiDAR equipment

A LiDAR system is mounted on the geometry car, and another system is mounted on a hi-rail (bi-modal) vehicle.

It activates at crossings using the latitude and longitude coordinates of the crossing reported in the GCI.

The system is capable to scan grade crossings at speeds up to 55 mph

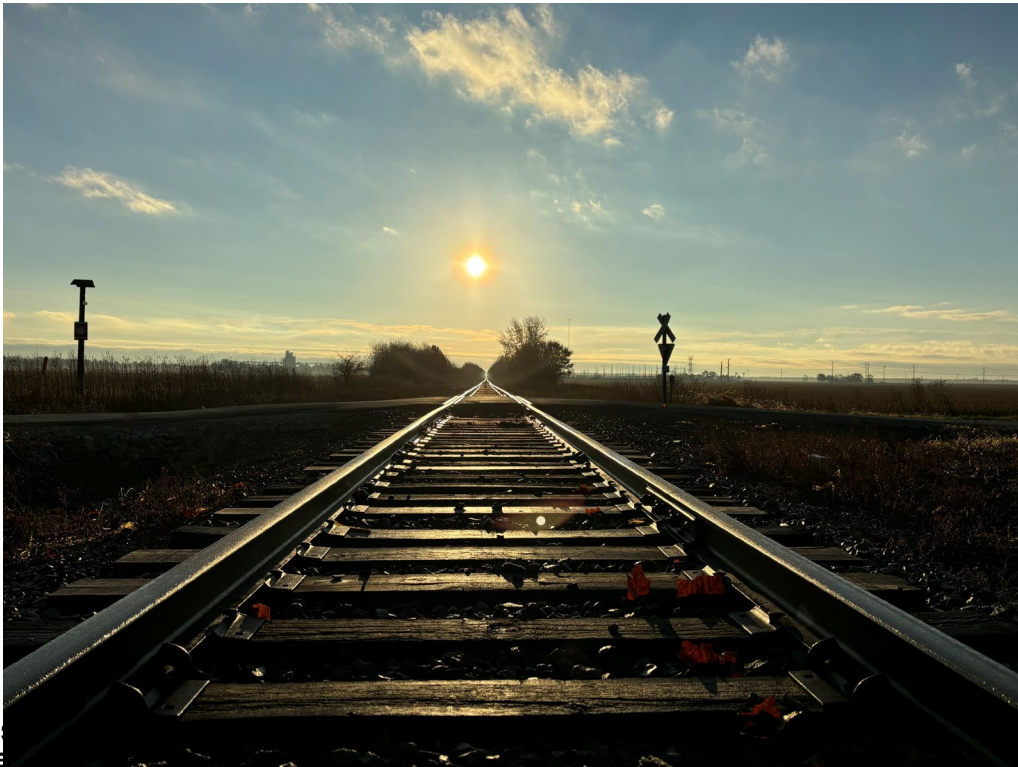
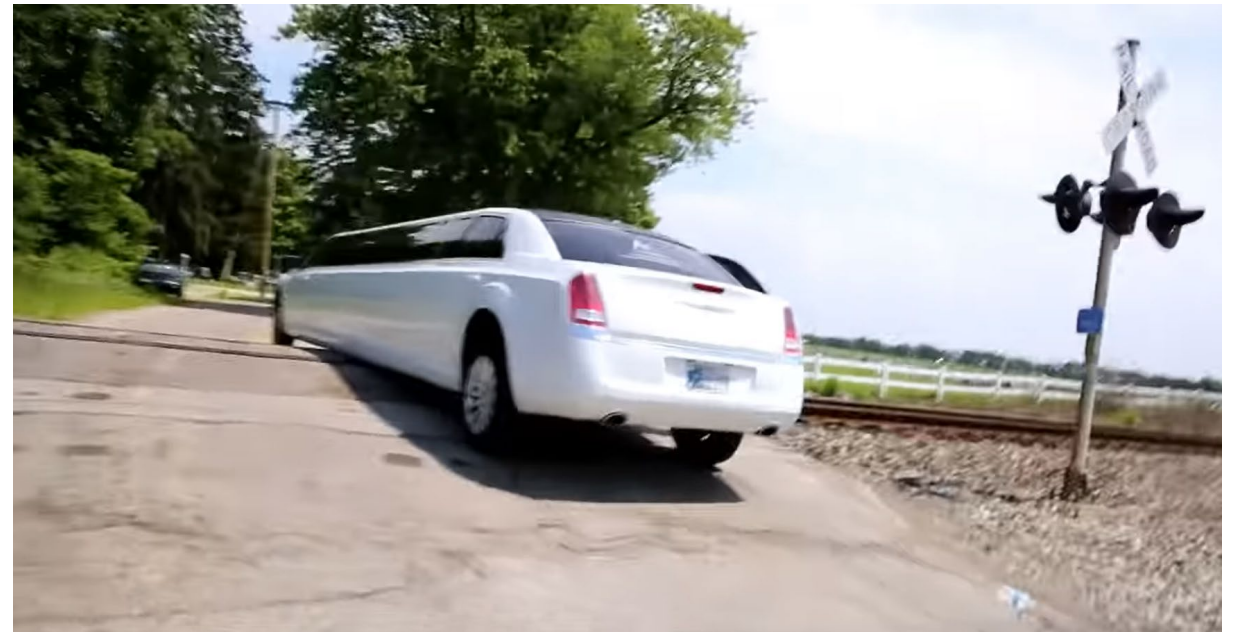
Grade Crossing Scans Summary

- ▶ Over 100,000 LiDAR scans
- ▶ 76,000 unique records, as of December 2025
- ▶ 60,000 crossings with at least one train per day and a nonzero difference in elevation have been included in the present analysis
- ▶ How many of these crossings meet the AASHTO guideline?

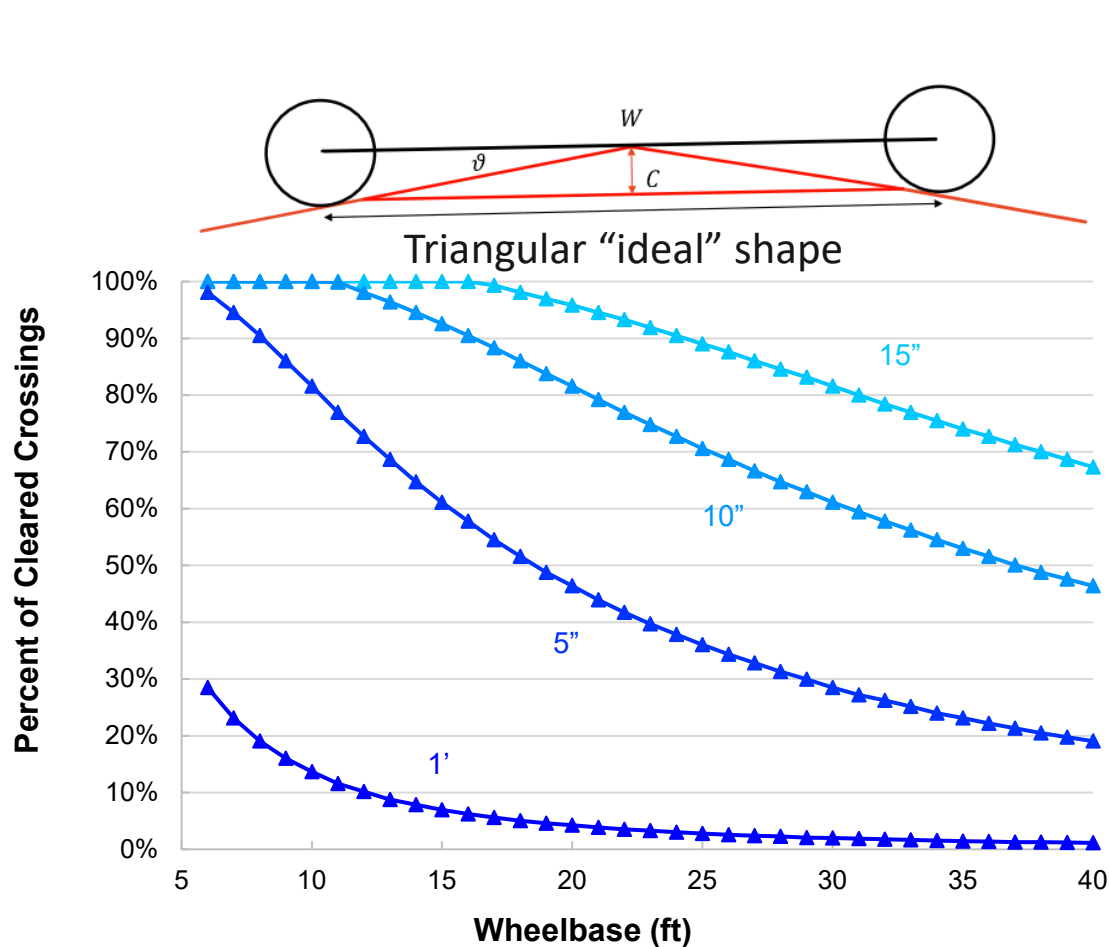
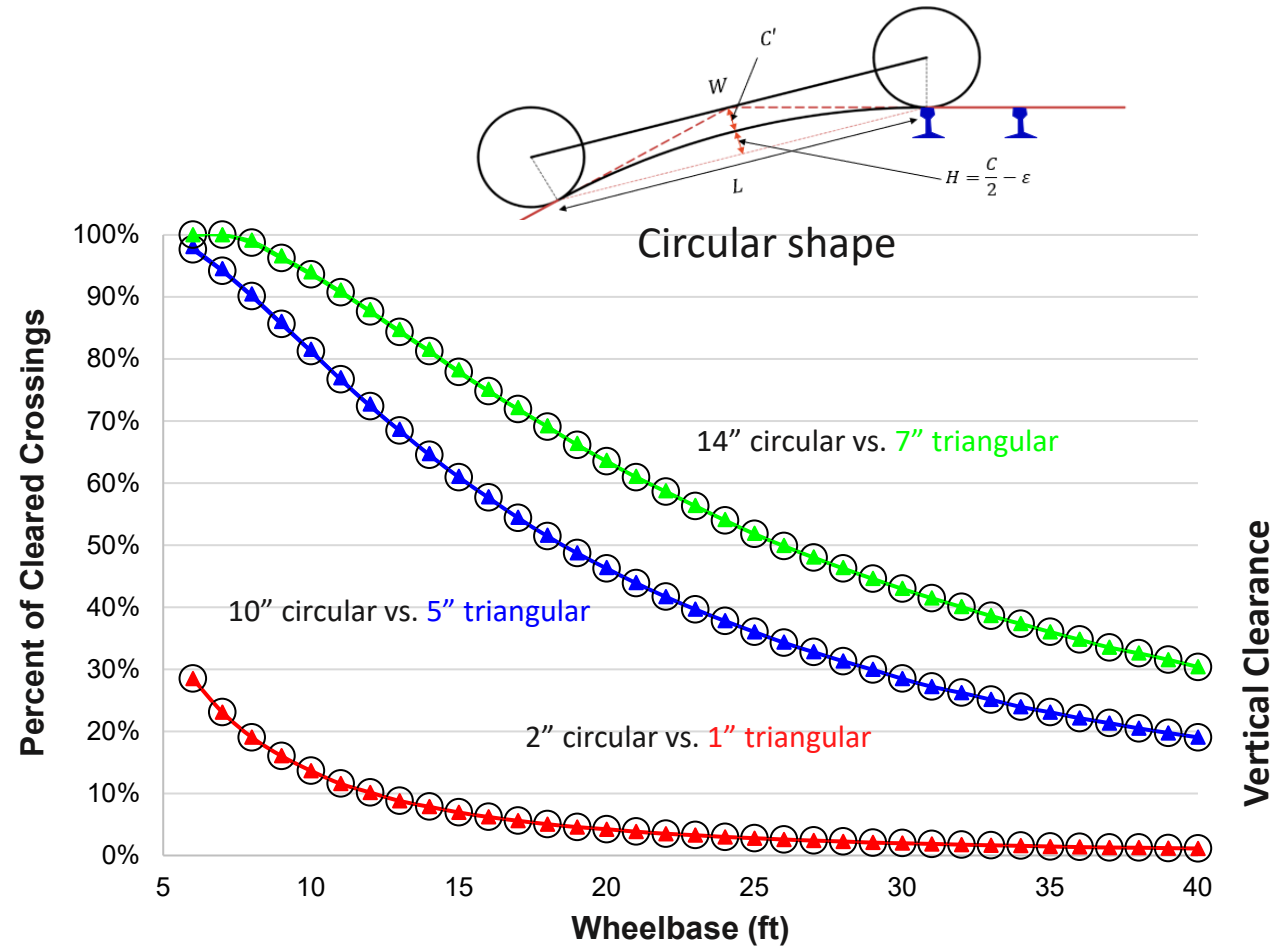
Theoretical Relationship Wheelbase – Vertical Ground Clearance and Level Crossing Vertical Profile

Designing a level crossing profile as a compound vertical curve with circular or parabolic transitions mitigates the risk of a hang up.
